HOUSE OF THE TEMPLE

• Renovation Update for October/November 2011 •

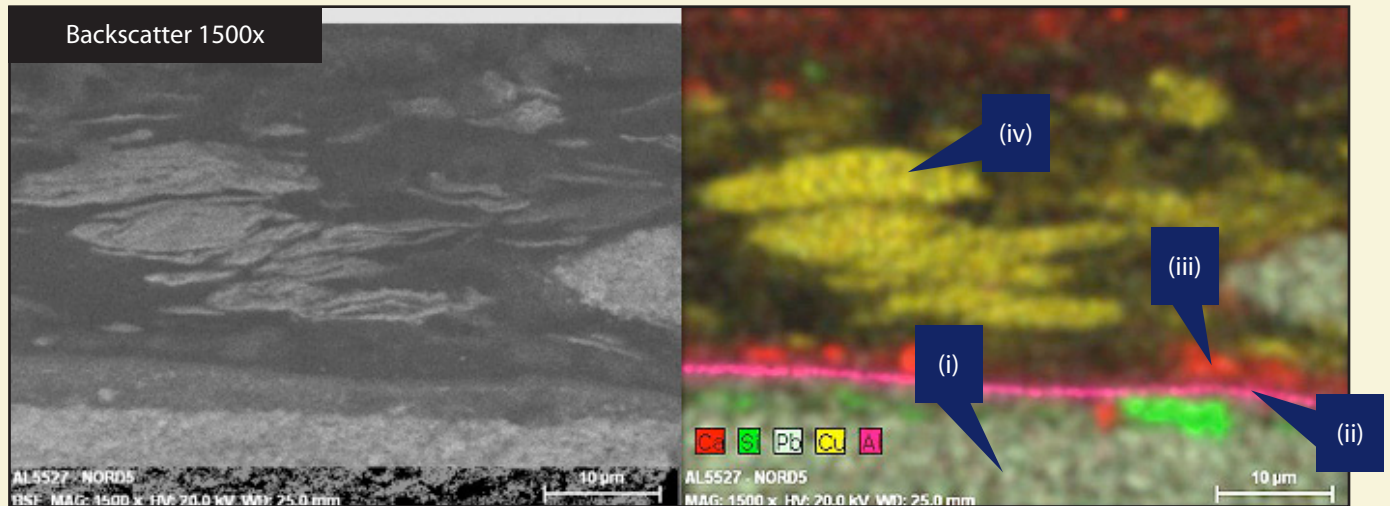
The above cross sections are magnified to 1500 times the original to allow analysis and review. The original paint was a gray stone colored paint (i) is essentially lead based (Pb; gray); over this gray layer is a yellow 'bole' or pigment containing aluminosilicates and lead (gray= Pb; green =Si; red=Ca; pink=Al). Next surface is the Aluminum leaf (ii) (pink line=Al). The red (Ca) is due to CaCO₃ (chalk; a 'lake' or absorbent base material for an organic dyestuff). The large chunks of the red are coincident with the tinted yellow glazing layer (iii) over the aluminum leaf. Over this layer is a brass powder metallic paint (iv) (yellow, Cu; Zn=green, shown above).

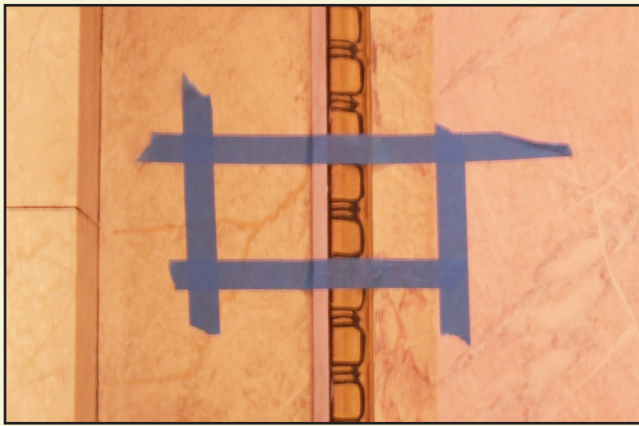
Following preliminary analysis of the wall treatments, a small section above (before) was exposed to reveal the various treatments.

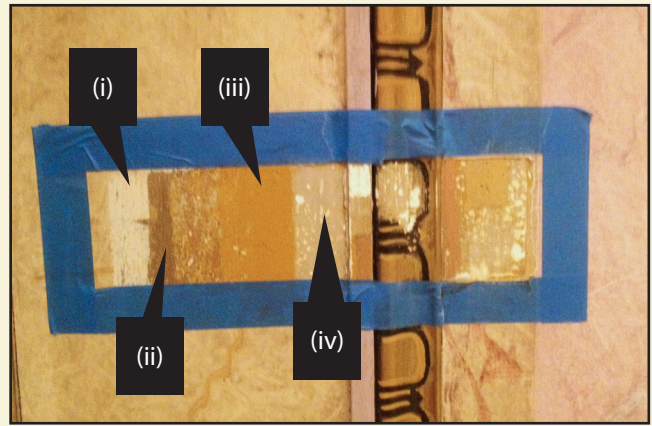
Layers of paint and other coatings were removed to expose the four different treatments.

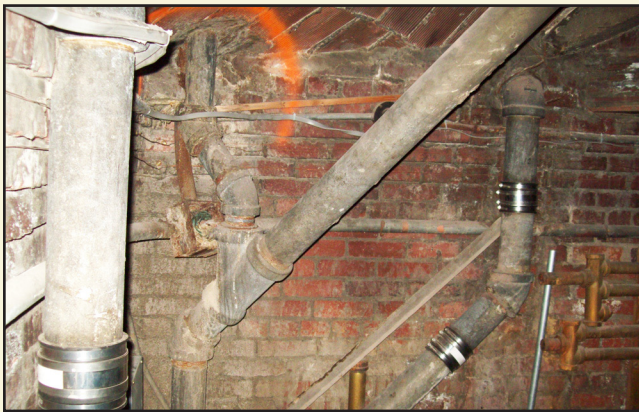
Rain leaders were reviewed and cameras used to observe the condition of pipe interiors. . Some cracks in the cast iron pipes in the areaways were observed. Any galvanized pipe remaining in the building is deteriorated and will need to be replaced as part of the renovation.

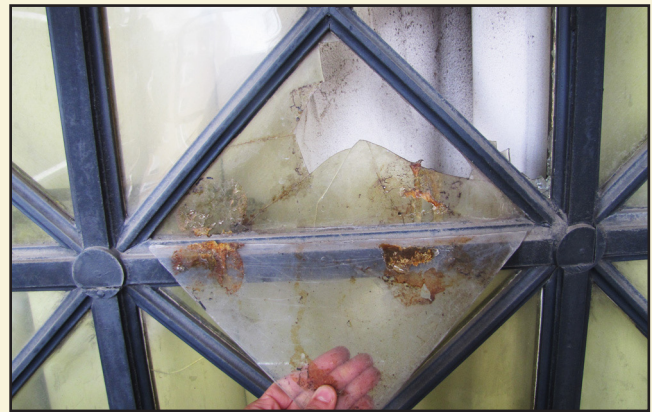
Example of Temple Room glazing which cracked during the earthquake. New glass is being fabricated and will be installed to make the window weather-tight. The yellow cast is accomplished by "painting" a glaze onto clear glass and then firing the glass in an oven. The glass is a deeper yellow at the bottom of the window transitioning to a light yellow at top of window.
