HOUSE OF THE TEMPLE

• Renovation Update for January 2012 •

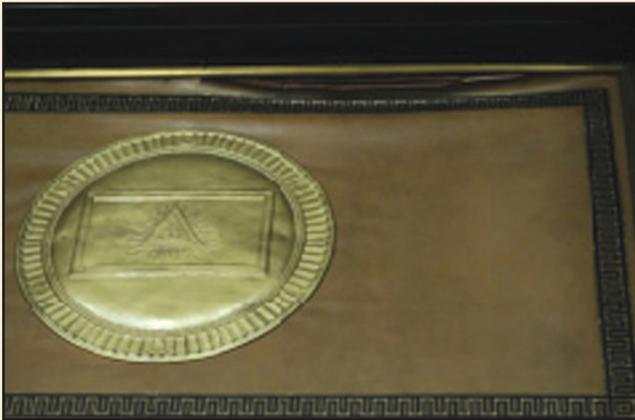
The August 2011 earthquake caused delamination of the leather panel at the door to the Temple Room. Sections of the bronze moldings were removed from the top and sides of the leather panels as needed to provide access for treatment by removing face screws.

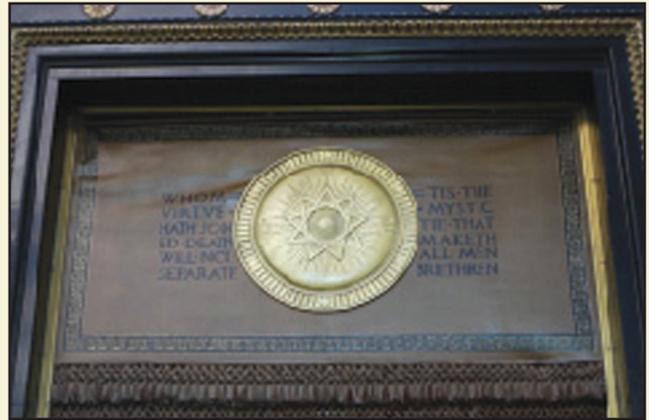
It was found that the leather had been directly applied to wood framing in-situ and was not installed on a separate panel. All leather was extremely desiccated and vulnerable to tearing. As such, it was decided to treat the panels in place rather than by removing them in order to reduce risk of introducing further damage.
