# HOUSE OF THE TEMPLE

## • Renovation Update for May/June 2010 •

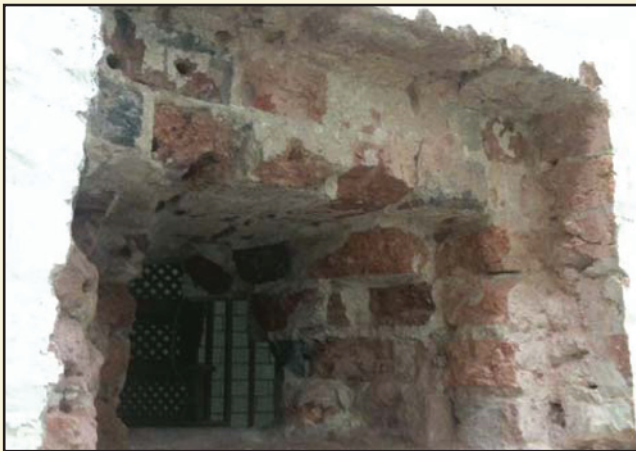
Investigations to determine the thickness and composition of the masonry walls surrounding the spiral stair in the NW corner were conducted. A through-wall penetration of approximately 2-feet by 2-feet by the depth of the wall was accomplished at the basement level and at the mezzanine level. The brick walls are approximately 33-inches thick solid masonry.

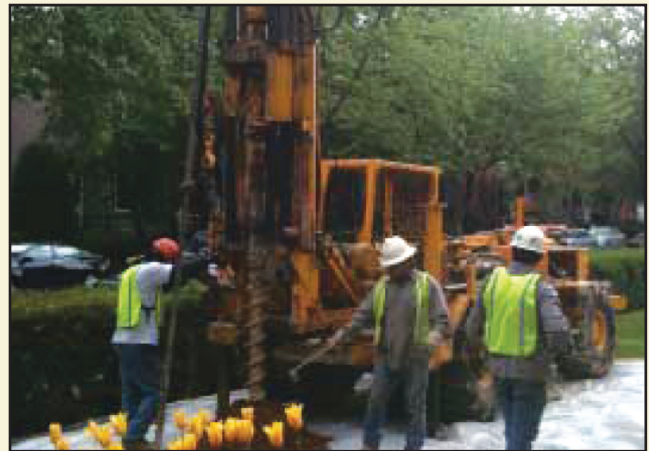
Wells were installed in the north lawn and in the southeast parking area to determine the level of ground water relative to the basement and boiler room levels. Water was found to be at approximately the level of the basement.

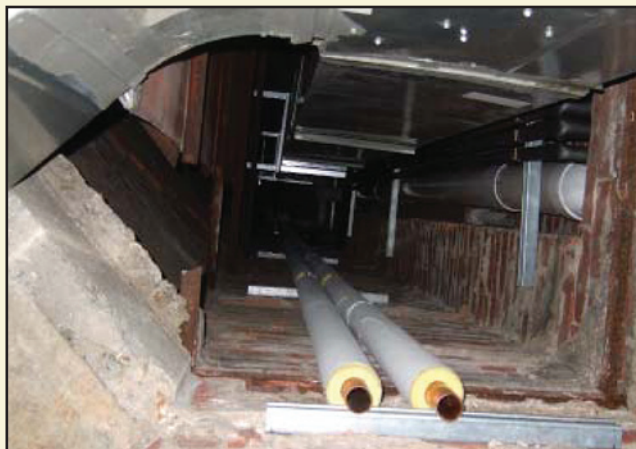
As part of the elevator proposal to connect the Temple Room, Atrium, and Banquet Hall, the SE shaft was investigated. Piping, electrical wiring and abandoned ductwork was visible in the shaft.

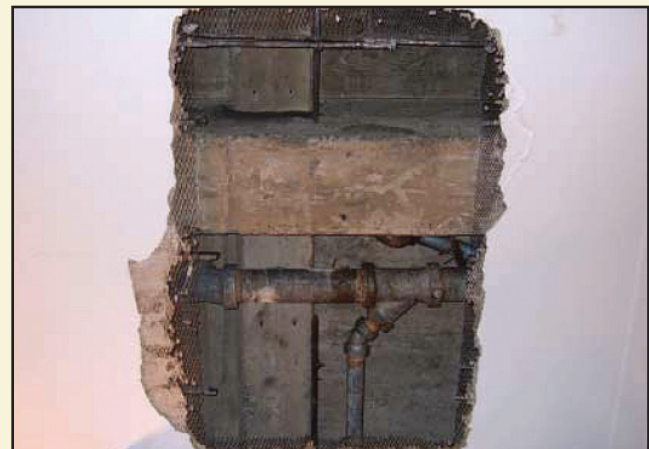
The ceilings of the Ground Floor level were opened to determine how fire suppression, electrical and duct work systems could be run. In the Burns Library, the ceiling is tight to the underside of the north/south concrete encased steel beams.

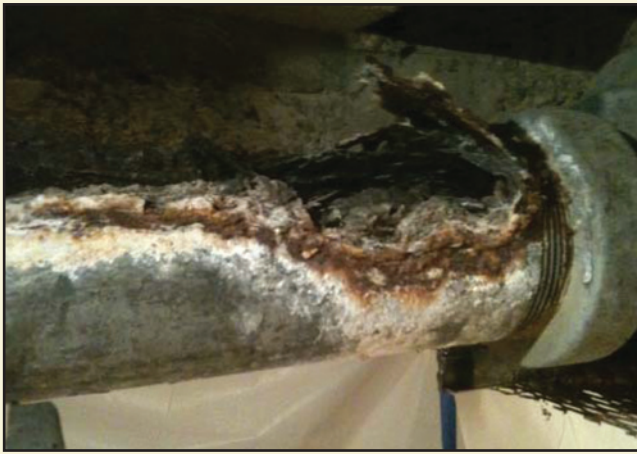
In the Burns Library, the penetration also allowed the team to find the source of the plaster deterioration; failed/corroded pipes from the bathroom on the Entrance Level had allowed moisture to saturate the ceiling of the Burns Library. The failed piping is currently being capped/replaced.

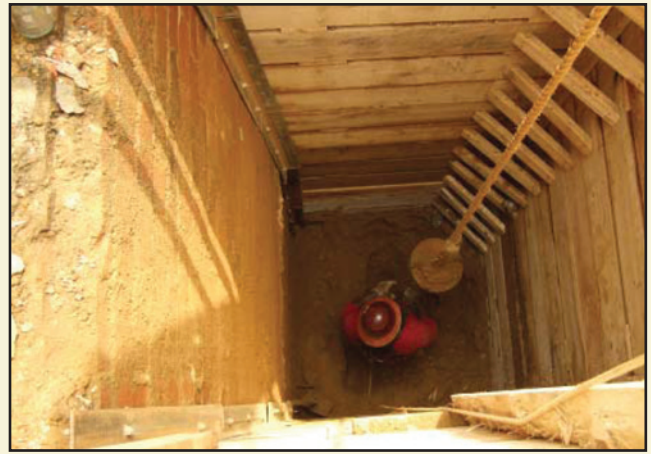
The footings were found 22'-3" below grade. The moat wall is composed of concrete with waterproofing on the lawn side protected by brick veneer. The soil was damp throughout the investigation but became more saturated about 19-feet below grade (consistent with the piezometer readings).

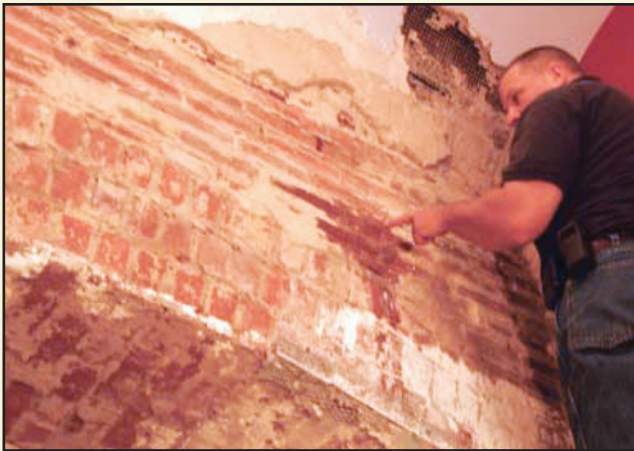
Water penetrations into the building have been significant over the years. One area of persistent leaks have been into the Ground Floor Men's Room. Moisture from the Main Entrance Stairs has penetrated through the wall below the sphinx and saturated the plaster below in the Ground Floor Men's Room. A water test was undertaken to find and identify the source. Measures to eliminate the leaks will be incorporated into the building renovation.

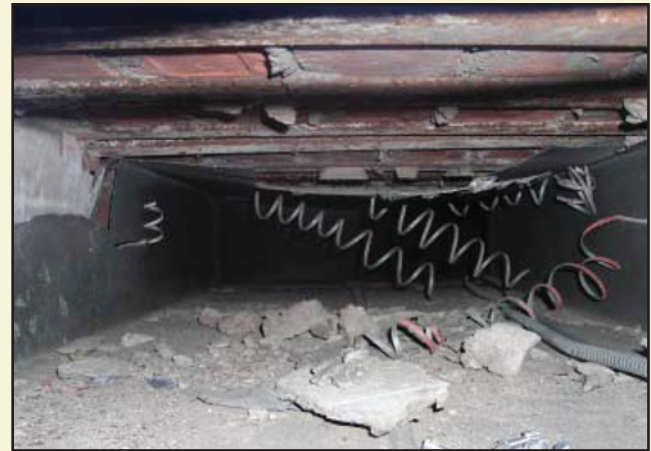
As part of the investigation of the mechanical ductwork system, several ducts were opened and the associated brick chases were measured. A significant number of the original ducts were capped and abandoned in place. Removing the existing, abandoned ductwork will allow the routing of the new. Existing ductwork is not insulated and cannot be reused. The existing chases matched the dimensions on drawings almost exactly giving the team confidence in the original drawings.
