# HOUSE OF THE TEMPLE

## • Renovation Update for July 2010 •

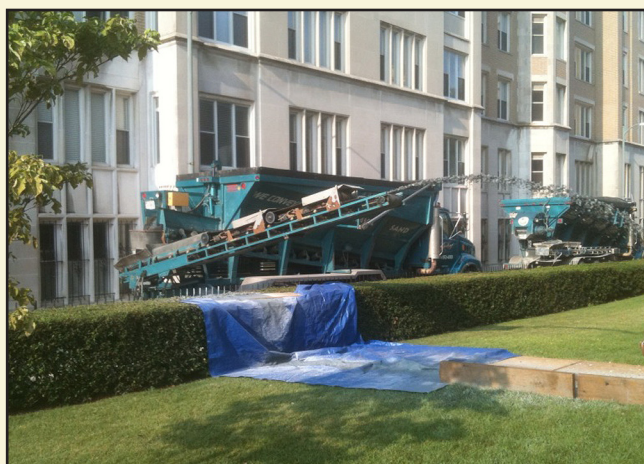
Following the completion of the moat wall investigation, the excavation on the south lawn was filled with gravel. The truck parked in the alley and “shot” gravel into the hole. Waterproofing and brick protection course were also repaired as part of the work.

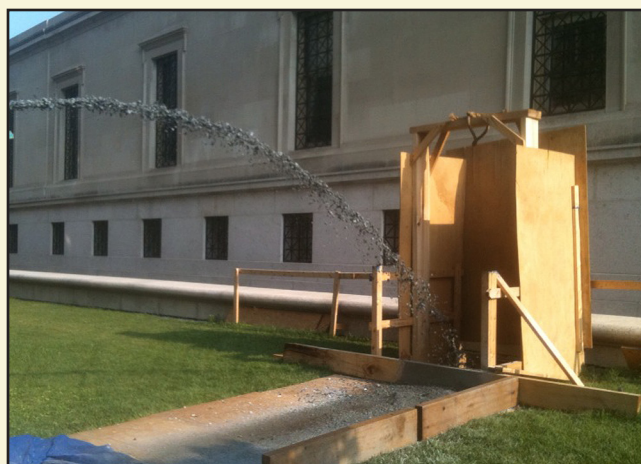
The gravel was “shot” into the hole. Waterproofing and brick protection course were also repaired as part of the work. Subsequent to the backfilling of the excavation, the temporary protection was removed and sod was installed.

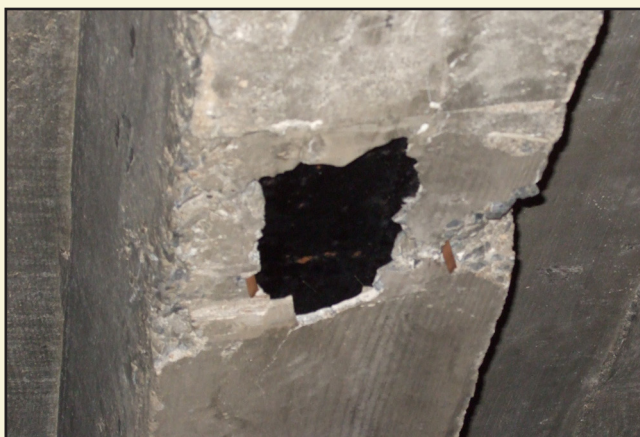
As part of the review of the concrete encased beams under the lower roof (above the Executive Director’s Suite), one beam did not appear to receive the original concrete encasement. This situation is highly unusual, however, it afforded the opportunity to confirm the structural steel is not deteriorated.

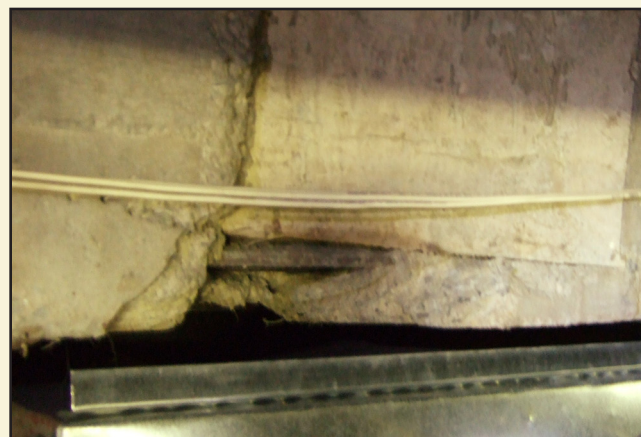
In the east attic above the library stacks, the concrete encasement is missing revealing the steel beam. The bottom flange of the exposed steel beam does not show any evidence of corrosion.

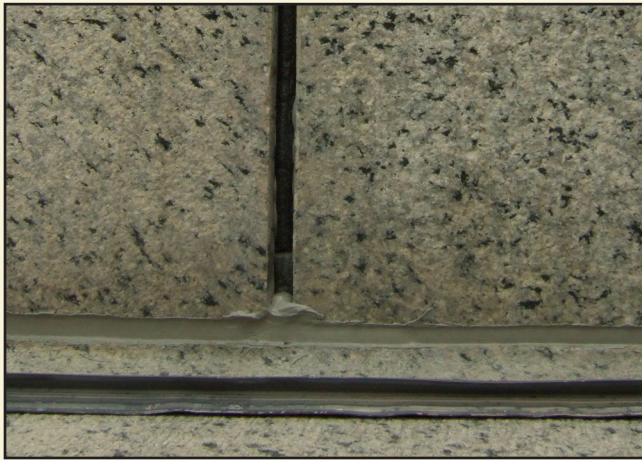
The existing, failed sealant joints are removed, new sealant and backer rod are installed in the open joints before the lead joint cover is installed.

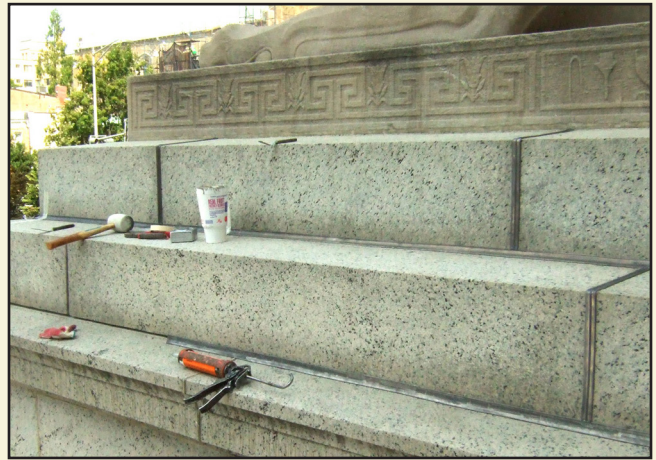
As part of the effort to minimize water infiltration into the building, the deteriorated sealant joints on the Sphinx pedestals are being replaced and protected with a lead cap.

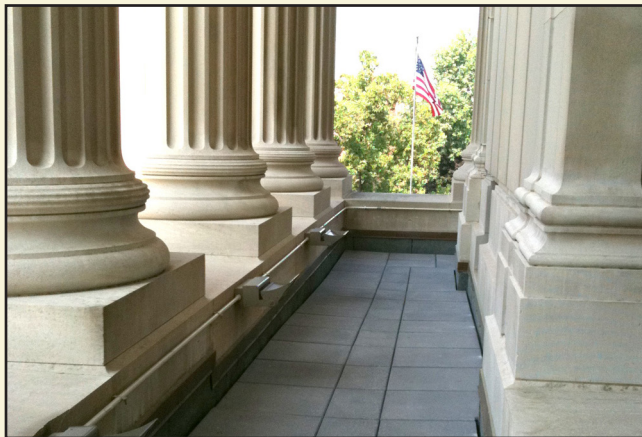
At the colonnade level, the existing failed roof membrane has been replaced with new roof membrane system with pavers.

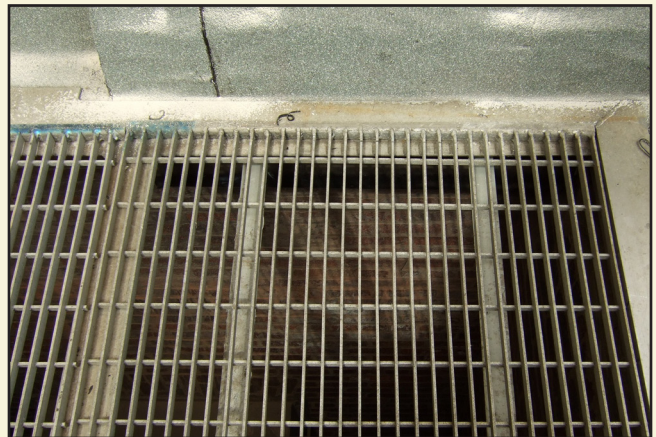
At the Colonnade roof, the replacement of deteriorated steel beams and installation of waterproofing in the air intake shafts and the new metal grates is complete.
