HOUSE OF THE TEMPLE

• Renovation Update for June 2011 •

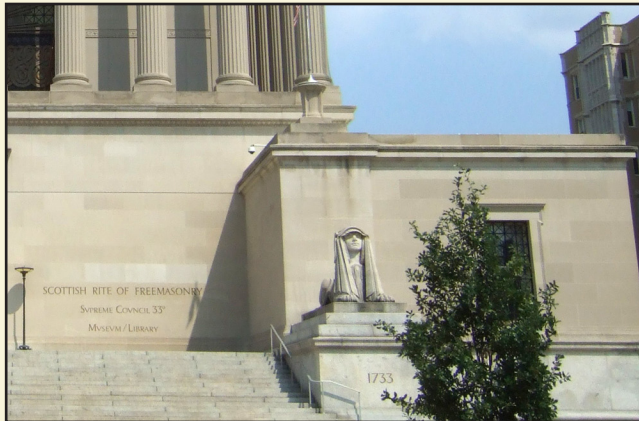
Before this current cleaning/restoration effort, heavy soiling was noted at the cornices and parapets of the west elevation. Additionally, four panels directly above the inscription on the building were inconsistent with the adjacent stone. Documentation indicated these panels were replaced with new in the last 25 years.

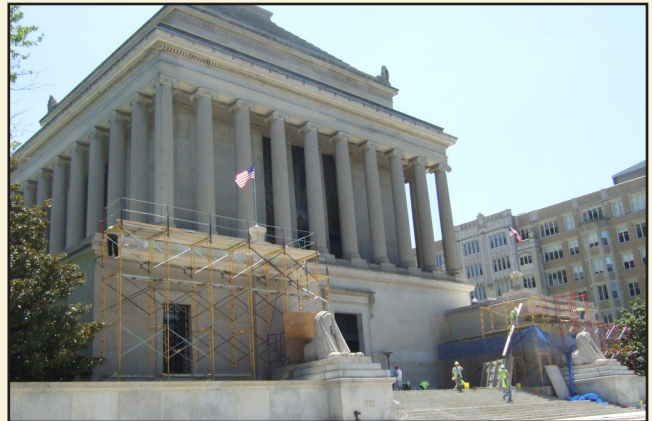
Scaffolding was temporarily installed on the north and south sides of the entrance to provide access to the stone walls.

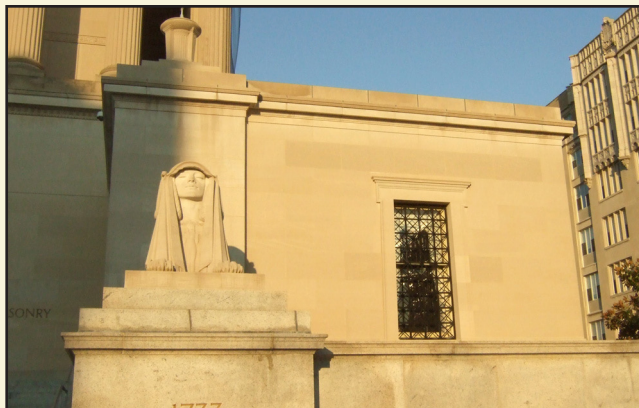
Following cleaning, the sphinx and walls are brighter with the heavy soiling removed as part of the cleaning. Malleable joint covers were installed on the top part of the wall to keep water from tracking down the joints.

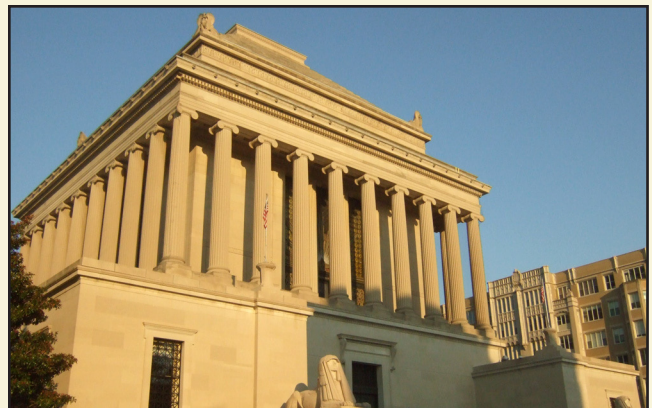
Where joints between the limestone were missing, new pointing mortar was installed. Once the overall building renovation is underway, the colonnade level and stepped roof will also be cleaned and restored.

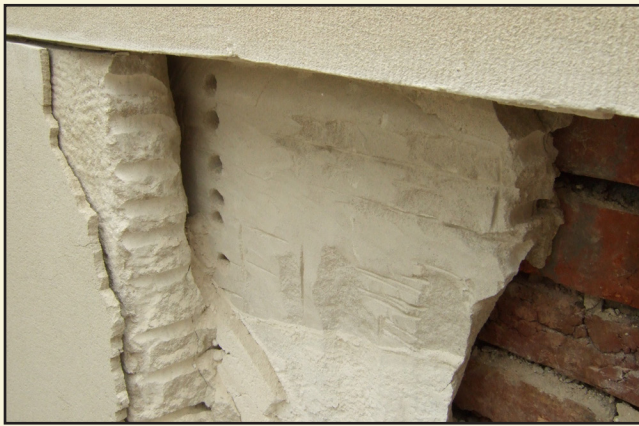
As the masons carefully cut out the joints of the stone panels to be replaced, they discovered that the surface was not stone but rather a mortar patch. Behind the mortar layer, was a later of stone, another layer of mortar, another later of stone mortared directly onto the brick back up wall which is inconsistent with the original drawings.

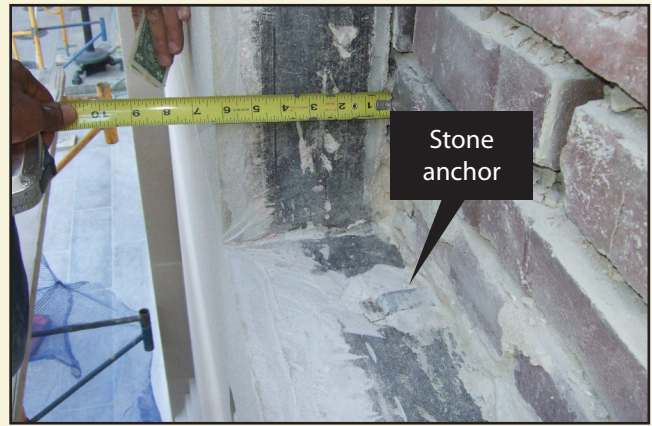
Once the non-original stones were removed, the original detail of the stone and brick was identified. Typically, the stone is six inches thick with a layer of mortar between stone and brick . Stone anchors were also identified in the construction of the wall.

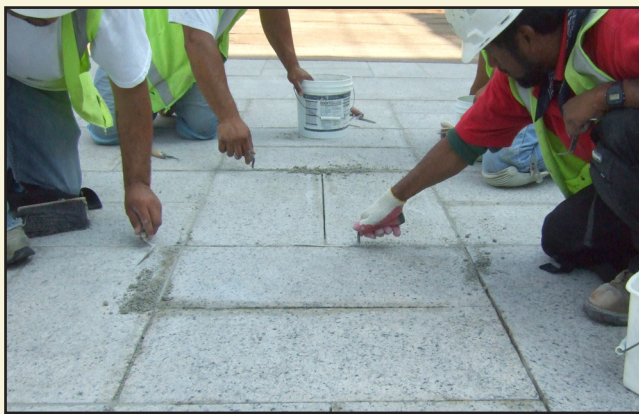
The joints between the stones on the plaza had deteriorated or were missing allowing water to migrate to the space below. After several mortar tests, the remaining material in the joints was removed and new mortar was installed.

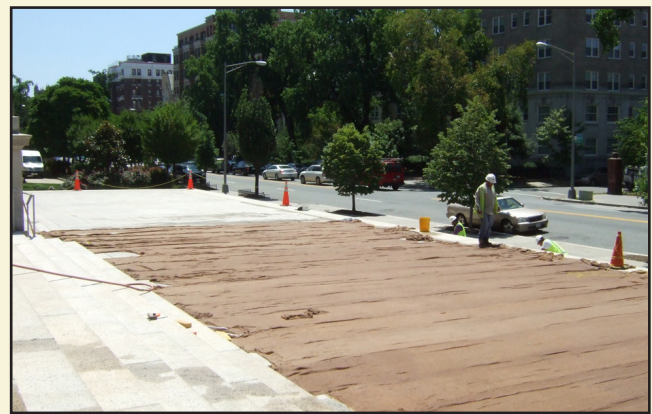
Damp burlap sheets where placed over the new mortar to allow the mortar to cure properly.
