HOUSE OF THE TEMPLE

• Renovation Update for March 2011 •

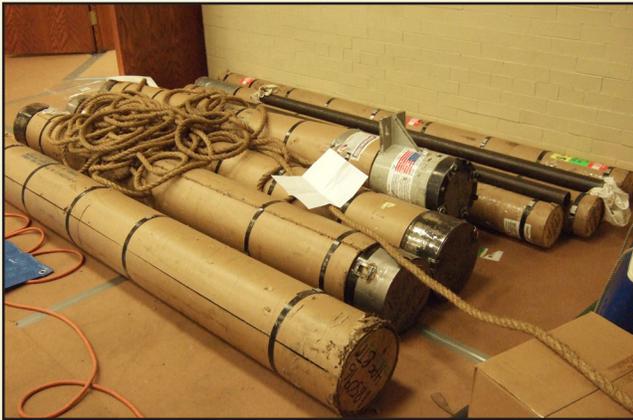
Prior to the start of the work at the basement level, the exhibit was removed, plastic sheeting and masonite boards were installed to protect the space. The new hydraulic jack for the elevator awaiting installation.

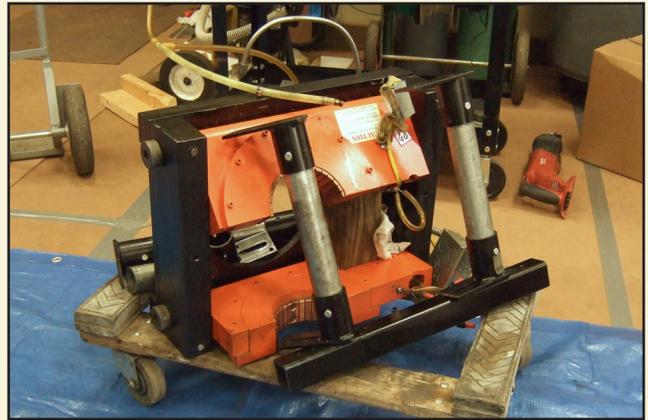
The safety device (also known as the "Jaws of Life") was removed from the jack for reinstallation on new jack. In the event of a failure, this device closes on the piston and stops the cab from falling.

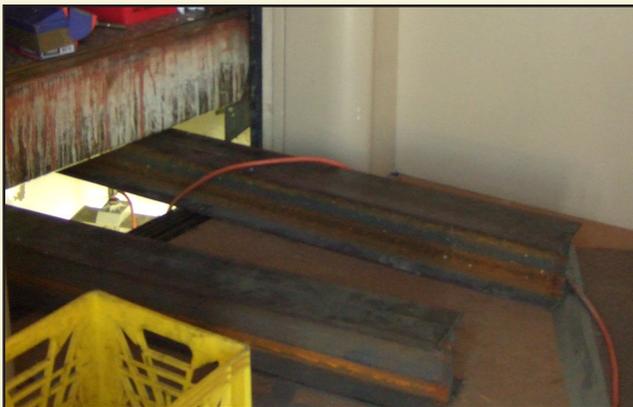
Steel beams temporarily support the elevator cab at the parking lot level.

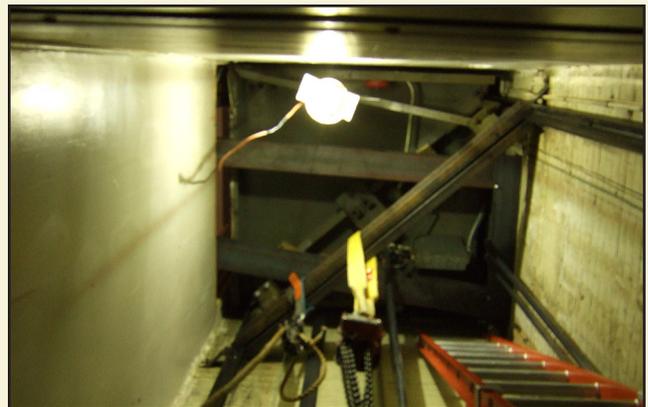
To allow the elevator jack to be removed, the elevator cab was raised to the parking lot level and temporarily supported on steel beams. Image is of the underside of the cab.

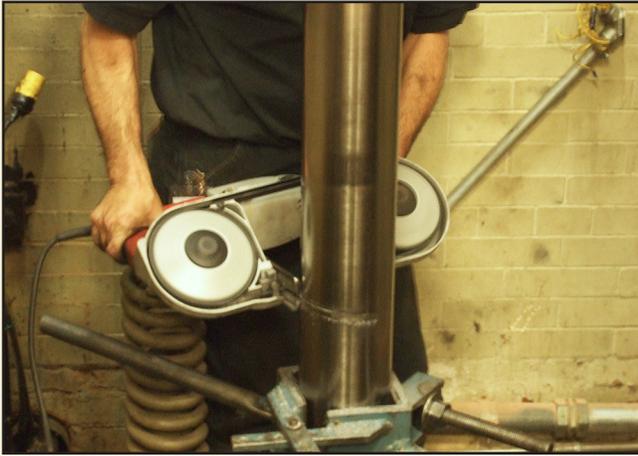
The steel jack was cut into small pieces and removed from casing. In several instances rust was visible on the jack.

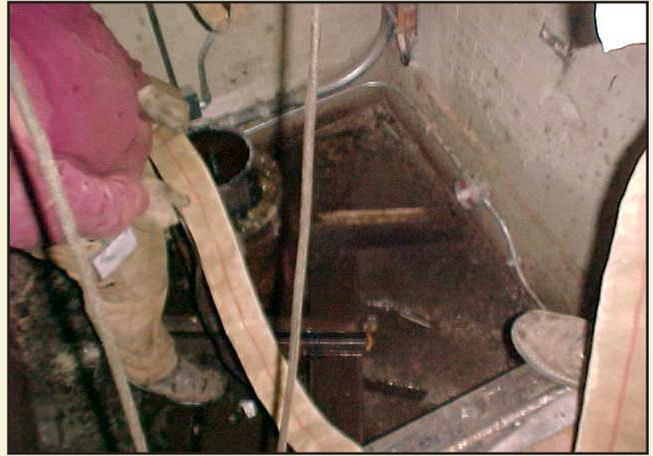
Hydraulic jacks were used to hoist the casing out of the hole.

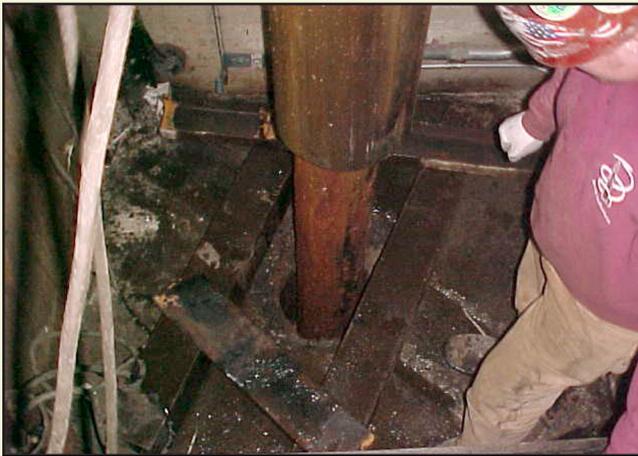
The casing and jack being removed from the hole. The old jack was only 11-feet into the ground. The new jack (to meet code) will be 31-feet into the ground.

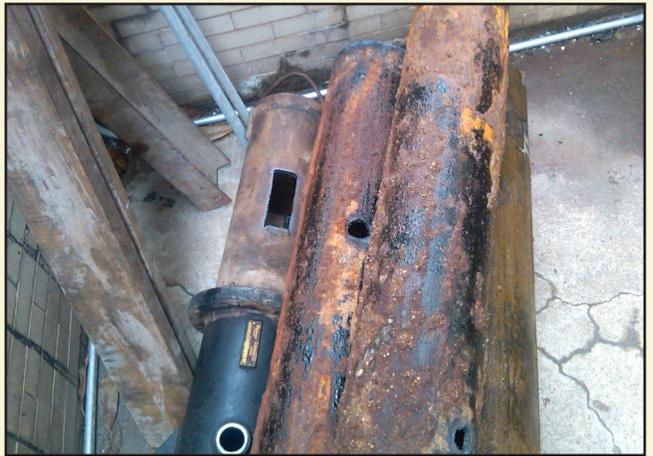
The original casing shows fissures and rust. A new steel casing with a PVC liner will be installed around the new hydraulic jack protecting the steel from corrosion. The new casing is welded together.
