HOUSE OF THE TEMPLE

• Renovation Update for October/November 2011 •

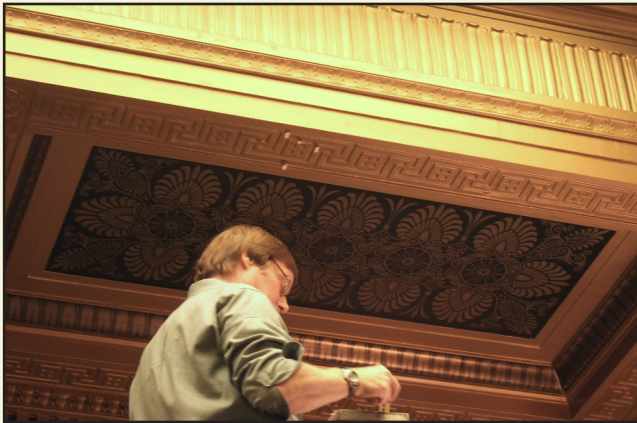
Richard Wolbers, Associate Professor, Coordinator of Science and Adjunct Paintings Conservator at the University of Delaware, is taking samples of the various painting treatment on the ceiling beams in the Executive Chamber.

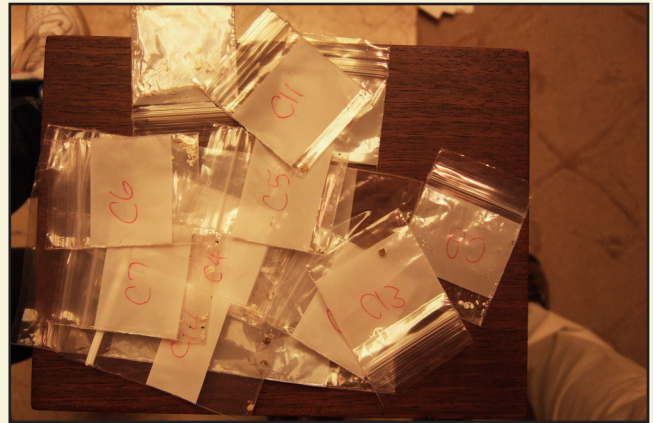
Over 30 samples were collected from the walls and ceilings to be analyzed. The samples are approximately 1.5 mm or 1/16 inch in diameter.
